STUDY ON IMPROVING SUPERVISION OF THE APRON MOVEMENT CONTROL UNIT IN THE MAKEUP BREAKDOWN AREA OF FATMAWATI SOEKARNO AIRPORT IN BENGKULU

Politeknik Penerbangan Indonesia Curug

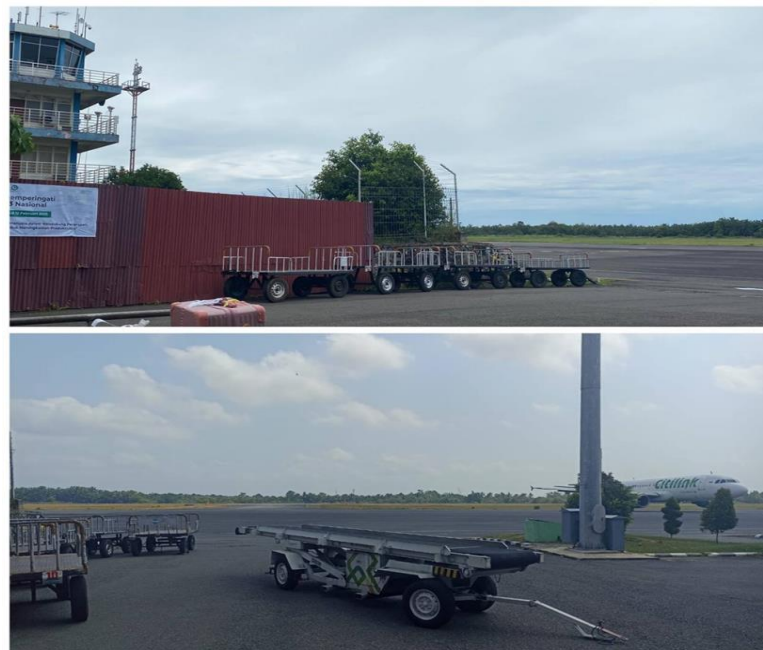
Figure 1 Ground Support Equipment (GSE)

The image above shows a violation of order by Ground Handling personnel, namely the improper placement of Ground Support Equipment (GSE) vehicles. Due to the absence of an Equipment Staging Area (ESA) at Fatmawati Soekarno Airport, Ground Support Equipment (GSE) vehicles must be placed in the Equipment Storage Area (ESA). In this case, the Baggage Conveyor Loader (BCL) was left in the Breakdown Area without supervision from the Ground Handling personnel.

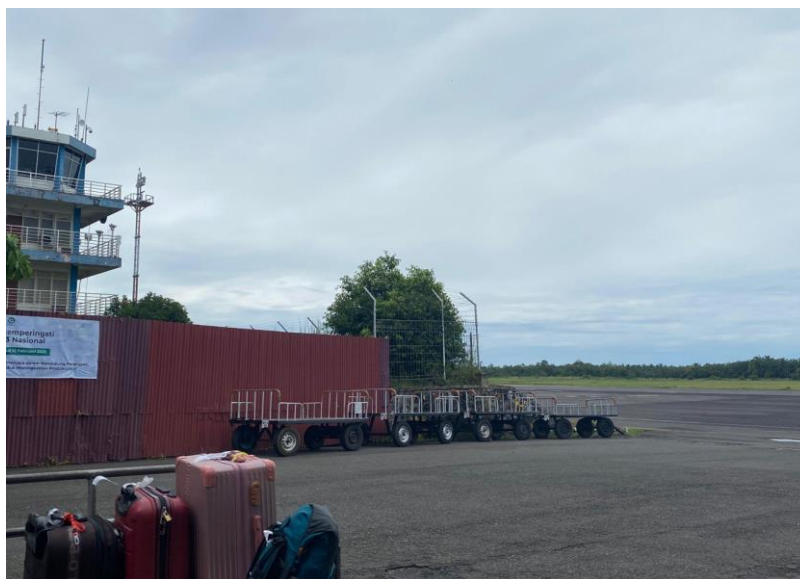
Figure 2 Baggage chart

1. Baggage Chart Placed Randomly by Ground Handling Staff;

In accordance with the standards set forth in the Director General of Civil Aviation Decision No. SKEP/140/VI/1999 on “Traffic Regulations in Movement Areas,” Chapter IV, Article 28. There has been a violation of order by ground handling personnel, namely the improper placement of Ground Support Equipment (GSE) vehicles. Due to the absence of an Equipment Staging Area (ESA) at Fatmawati Soekarno Airport, Ground Support Equipment (GSE) vehicles must be placed in the Equipment Storage Area (ESA). The improper placement of baggage carts in the make-up area can disrupt the smooth operation of baggage handling at the airport.

When baggage carts are placed haphazardly, the work area becomes narrow and difficult to access by Ground Handling personnel, thereby slowing down the process of loading baggage into the aircraft. Additionally, irregular placement can obstruct the movement of operational vehicles such as Baggage Towing Tractors, increasing the risk of workplace accidents and collisions between equipment. If this situation is left unmonitored, it may lead to disorder in workflow processes and increase the likelihood of baggage being misplaced, left behind, or damaged due to delayed processing. Therefore, clear regulations regarding the parking points for Baggage Carts and strict monitoring are necessary to ensure that each unit is placed in accordance with established procedures.

Based on the issue of misplaced Ground Support Equipment (GSE), it is necessary to improve the monitoring function of AMC personnel with CCTV connectivity in the AMC office so that AMC personnel can easily monitor conditions in the makeup breakdown area.

The airport must provide a dedicated parking zone for baggage carts with clear markings and signs so that each unit can be placed in accordance with established procedures. This area can be marked with boundary lines on the floor or information boards indicating the correct parking location. With an organized parking zone, the movement of operational vehicles such as towing tractors and baggage loading and unloading activities will be smoother and safer.

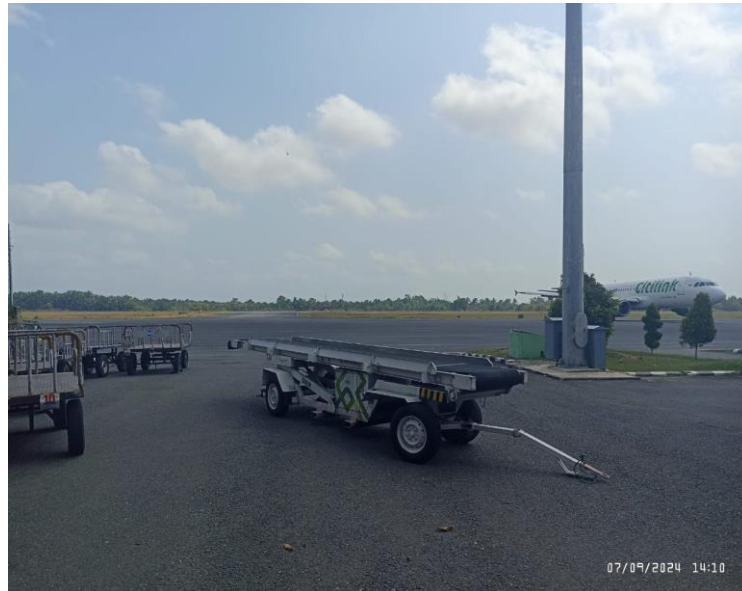
Figure 4 Baggage Conveyyor Loader

Based on observations at the Make Up Breakdown Area of Fatmawati Soekarno Airport in Bengkulu, it was noted that one Baggage Conveyor Loader (BCL) unit was left unattended by the Ground Handling personnel on duty. The placement of the Baggage Conveyor Loader (BCL) was not in accordance with the area designated in PR 21 of 2023 concerning the management of Ground Support Equipment (GSE).

This equipment should be under direct supervision to avoid potential operational disruptions and safety risks, especially since the placement location is in an airside area with a high risk level. The absence of personnel around the BCL could cause delays in baggage handling and pose hazards if the equipment is used improperly or

moves without control. This finding indicates the need for enhanced supervision by the AMC Unit over ground handling activities in the breakdown area, particularly regarding compliance with standard operating procedures (SOPs) and the work discipline of field personnel.

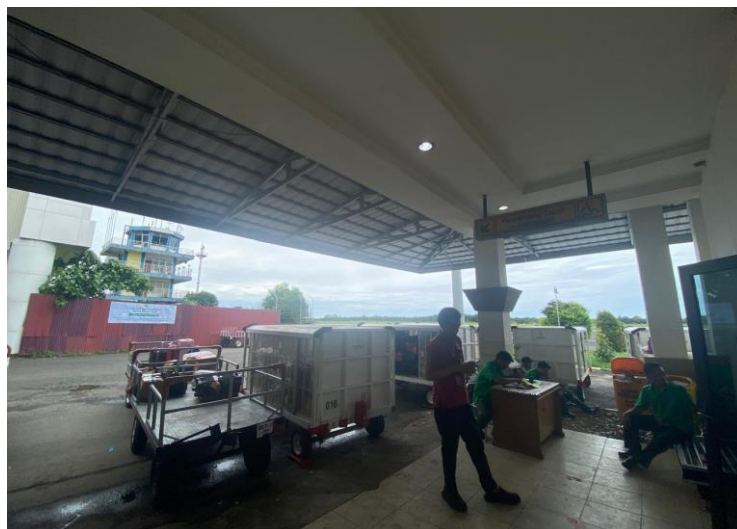
Figure 5 Ground Handling Personnel

2. Ground Handling Personnel Do Not Use Complete Personal Protective Equipment (Safety Shoes);

The lack of discipline among Ground Handling personnel while in the Makeup Breakdown Area, specifically by failing to comply with existing regulations—namely, not using Personal Protective Equipment (PPE) such as Safety Shoes—constitutes a violation of the regulations set forth in SKEP/100/XII/1985, regarding Airport Regulations and Procedures, In Chapter II, Article 4, Paragraph (1), it states that “Anyone present at the airport must comply with airport regulations and procedures” [12]. Therefore, it is deemed necessary to conduct more intensive supervision in that area. Currently, AMC personnel have been conducting routine inspections every morning and afternoon, but this is still considered insufficient for actual supervision because AMC supervision is more focused on the apron area. Refueling in Conjunction with Passenger Movement.

Compliance with SOPs and regulations is a key factor in maintaining safety and operational efficiency on the apron. Minor violations found in the field need to be addressed by: (a) Socialization and Education: Conduct intensive socialization regarding the importance of compliance with SOPs and PR 21 of 2023 and provide education about the risks and consequences of violations, (b) Regular Audits and Inspections: Conduct regular audits and inspections to ensure that all operational activities comply with applicable SOPs and regulations, (c) Imposing Sanctions and Awards: Implement a strict sanction system for violators of SOPs and regulations and give awards to units or personnel who comply with the rules. This will create a culture of compliance and increase personnel awareness of the importance of operational safety, and (d) Conducting a Ramp Safety Campaign: The objectives of the Ramp Safety Campaign include creating awareness among all personnel and service providers about the losses from incidents, including equipment and human casualties, and creating awareness that disruptions at the airport due to personnel working outside established procedures can threaten the safety of personnel in the Makeup Breakdown Area. By holding these seminars regularly and on a scheduled basis, it is hoped that personnel will understand safety in the airside area.

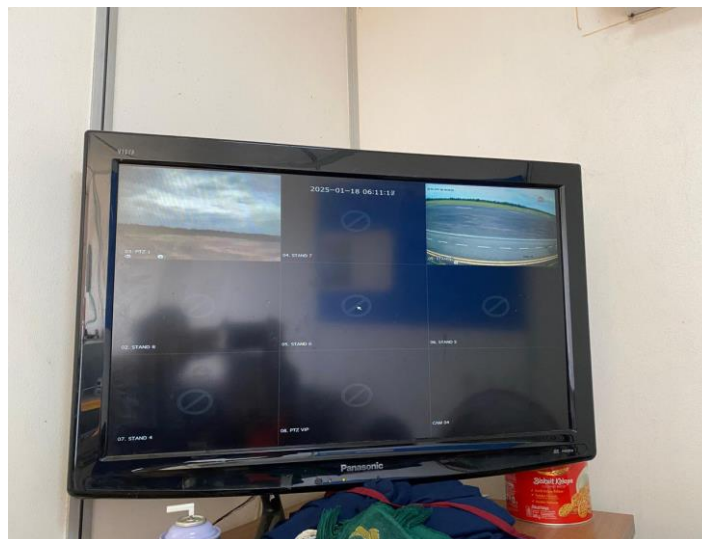
Figure 6 CCTV Makeup Breakdown Area

3. CCTV Access to The Makeup Breakdown Area in The AMC Unit is Not Connected

The image above shows the CCTV monitor screen display in the Apron Movement Control (AMC) monitoring room at Fatmawati Soekarno Airport in Bengkulu. It can be seen that most of the surveillance camera channels do not display visuals (blank), only showing access restriction icons or disconnected connections. Out of the eight camera channels that should be active to monitor various points in the Make Up Breakdown area, only two channels display real-time images of the airside area. This situation reflects technical challenges in the CCTV monitoring system, which directly impact the effectiveness of AMC Unit oversight of ground handling activities, GSE vehicle movements, and potential safety violations on the airside. The disconnection of most of these surveillance cameras indicates weak maintenance and monitoring of the technology-based security system, which should serve as the primary tool for anticipating operational risks and supporting quick decision-making on-site.

CCTV: Closed Circuit Television (CCTV) is a vital surveillance technology in enhancing security and operational surveillance effectiveness, including in the Make Up Breakdown Area at the airport. The installation of CCTV by the Apron Movement Control (AMC) unit in this area serves to monitor ground handling activities, baggage equipment movements, and potential violations of work safety procedures. With continuous visual recordings, AMC personnel can conduct real-time monitoring or review specific incidents, enabling them to respond quickly in the event of violations, workplace incidents, or procedural non-compliance. Additionally, CCTV serves as supporting evidence if needed during internal investigations. Therefore, the integration of an active CCTV system directly connected to the AMC Unit is a critical requirement for achieving more optimal supervision and preventing unwanted incidents.
